**98-06-04 EUROCOPTER FRANCE:** Priority Letter issued on March 4, 1998. Docket No. 98-SW-11-AD.

Applicability: Model AS332C, L, and L1 and Model SA330F, G, and J helicopters, certificated in any category.

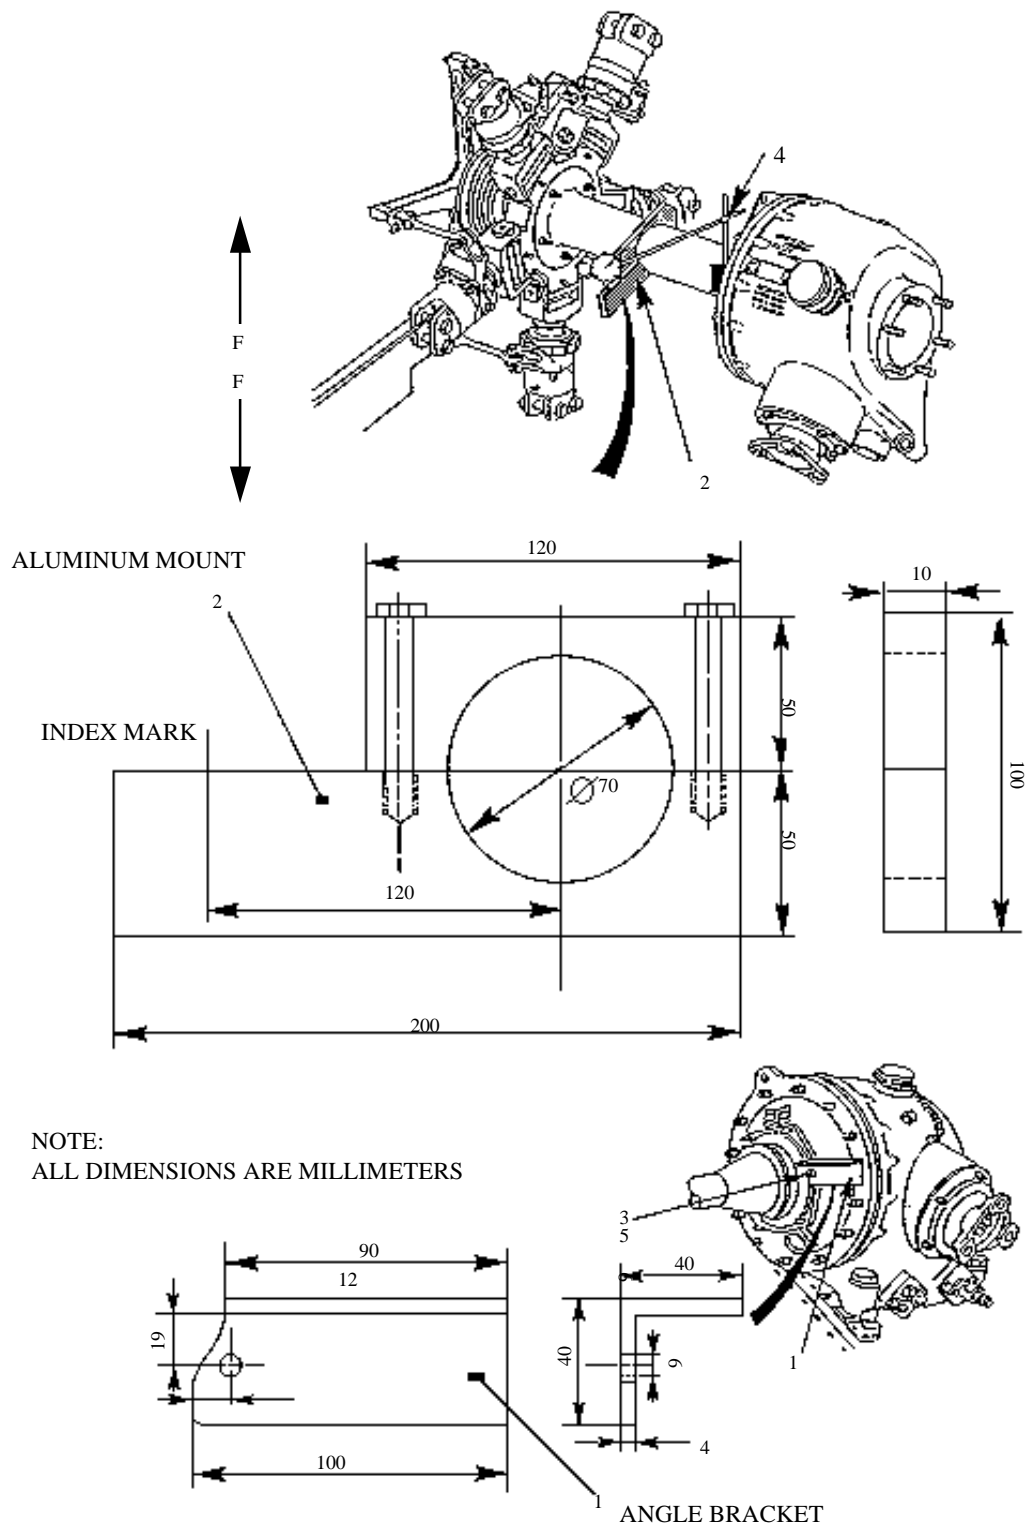
FIGURE 1

(a) For TGB that are not equipped with a tail rotor blade deicing system as shown in Figure 1, fabricate a steel angle bracket (angle bracket) (No. 1 of Figure 1) and an aluminum mount (No. 2 of Figure 1).

(1) Place a tail rotor blade in the horizontal position with the blade's tip facing forward.

(2) Immobilize the TGB input flange by placing a wooden block between the TGB input flange and the deck.

(3) Secure the angle bracket on the TGB output casing with a nut (No. 3 of Figure 1) and a washer (No. 5 of Figure 1).

(4) Secure the mount on the rotor shaft.

(5) Secure the dial indicator gage (No. 4 of Figure 1) on the angle bracket.

(6) Install the feeler of the dial indicator on the mount at the index mark which is 120 mm from the rotor shaft center line.

(7) Using a dynamometer, apply a 1 daN (2.25 lbs.) load in both directions (indicated by letter "F" in Figure 1), 30 mm from the blade tip, to measure the total play.

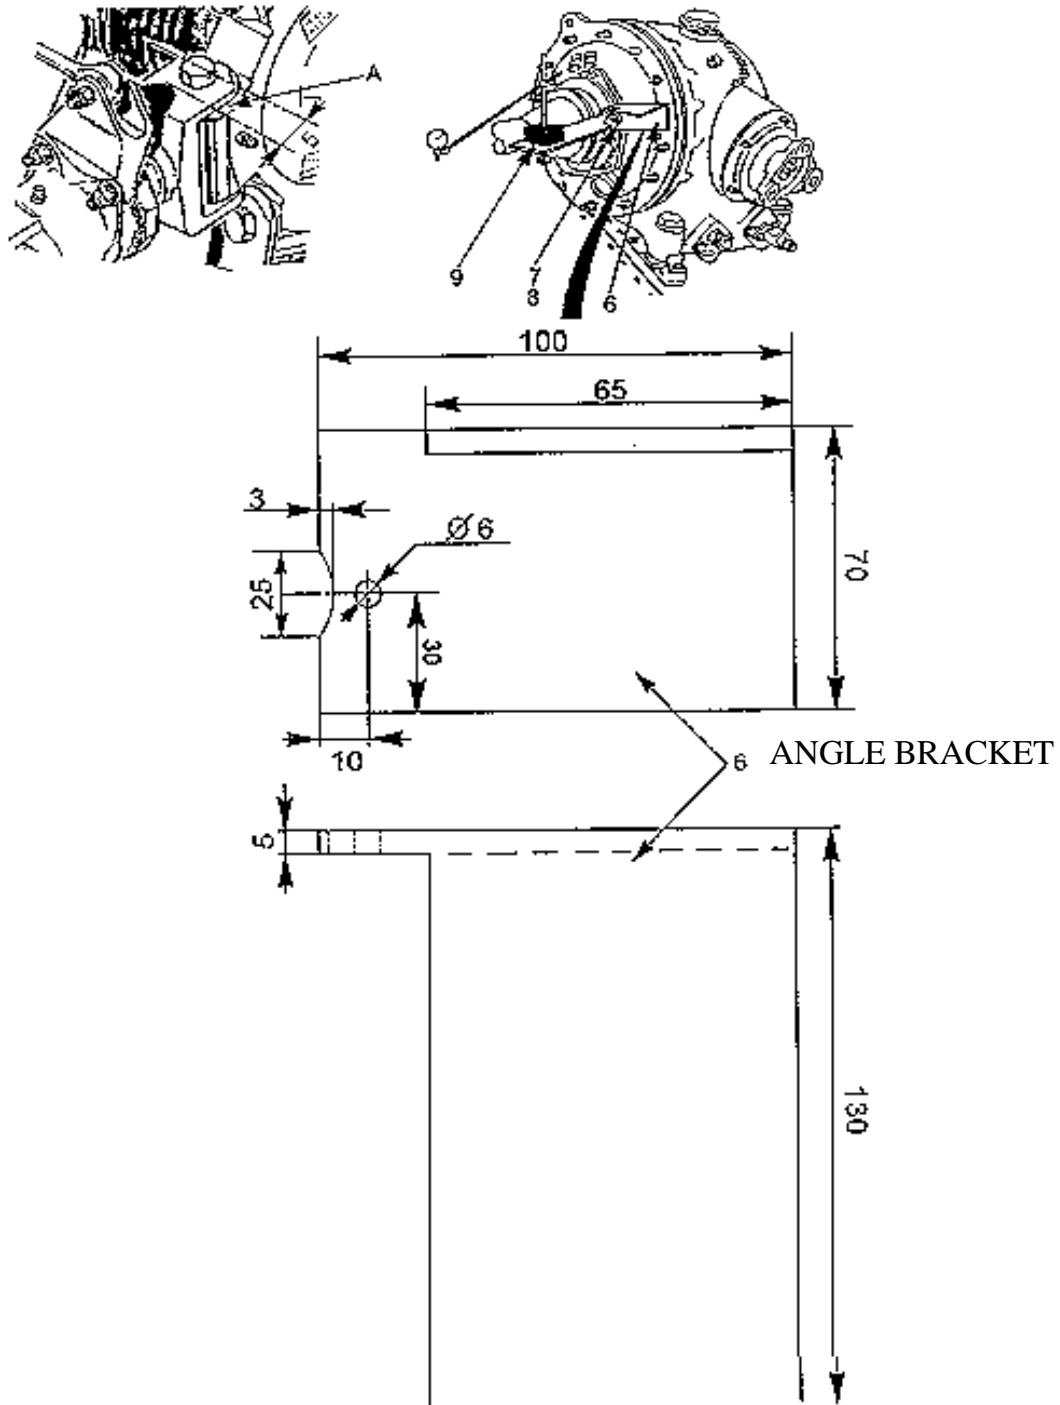
FIGURE 2

(b) For TGB that are equipped with a tail rotor blade deicing system as shown in Figure 2, fabricate a steel angle bracket (angle bracket) (No. 6 of Figure 2) from a 90 degree formed steel sheet.

(1) Place a tail rotor blade in the horizontal position with the blade's tip facing forward.

(2) Immobilize the TGB input flange by placing a wooden block between the TGB input flange and the deck.

(3) Secure the angle bracket on the TGB output casing with a nut (No. 7 of Figure 2) and a washer (No. 8 of Figure 2).

(4) Secure the dial indicator gage (No. 9 of Figure 2) on the angle bracket.

(5) Install the feeler of the dial indicator on the tail rotor hub, 5 mm from the spindle attachment bolt (Item A of Figure 2).

(6) Using a dynamometer, apply a 1 daN (2.25 lbs.) load in both directions (indicated by letter "F" in Figure 1), 30 mm from the blade tip, to measure the total play.
